# HOW TO READ YOUR ROOF

*UNDERSTANDING THE NATURAL AGING  
PROCESS ON ASPHALT SHINGLES*

**TAMKO**<sup>®</sup>  
BUILDING PRODUCTS LLC

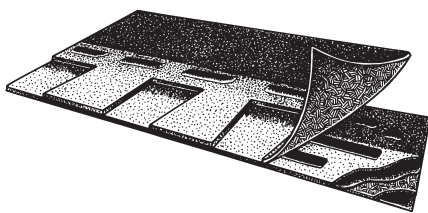
Laminated shingles consist of two or more layers bonded together, giving them added dimension for a shake-like appearance.

3-tab shingles are made with a single layer of fiberglass mat.

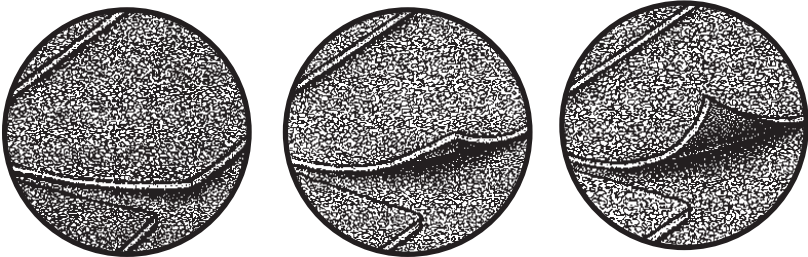
## CURLING

Curling is a common phenomenon in some shingles and is not a defect. It is natural for asphalt to age and asphalt layers to shrink with time. This shrinkage may result in the slight curling of the edges of the shingle.

Curling  
Surface cracking  
Closed blisters  
Algae stains  
Slight granule loss

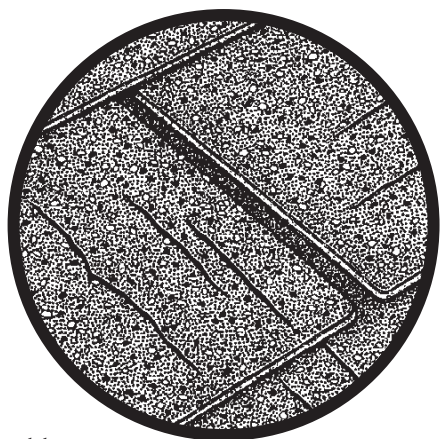
## SURFACE CRACKING

While minor cracks may not be noticeable from the ground, you might spot them while hanging your Christmas lights. Intense heat from the sun often allows protective asphalt oils to deplete, causing minor cracks. Keep in mind that these normal weathering characteristics are not cause for alarm as long as your shingles are still performing their intended purpose of shedding water. Cracks that penetrate through the fiberglass or organic mat should be investigated.

Open blisters  
Cracks visible through the fiberglass or organic mat  
Exposed asphalt due to granule loss

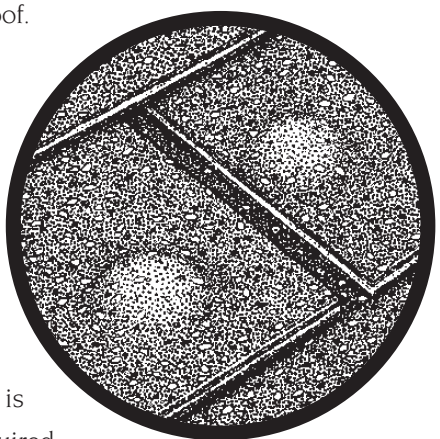
## BLISTERS

Occasionally, naturally occurring small, circular raised areas known as blisters may appear on your roof.

These pockets may vary in size and be open (exposing the asphalt) or closed.

Blisters are often a direct result of underventilated attics or excessive use of plastic cement. Closed blisters are not reason for concern as long as your shingles are still performing their intended purpose of shedding water.

However, open blisters do mean asphalt is exposed and immediate attention is required.

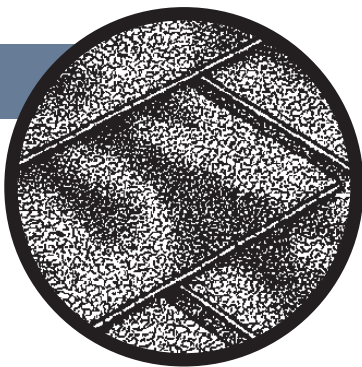
## ALGAE STAINS

In moist, humid areas, dark brown or black patches may appear on roofs. These streaks result in a dirty rooftop, often more visible on lighter-colored shingles. This naturally occurring stain is caused by algae growth and will not affect your shingles' ability to shed water. Algae discoloration should not be confused with moss or tree droppings, which typically produce only localized discoloration.

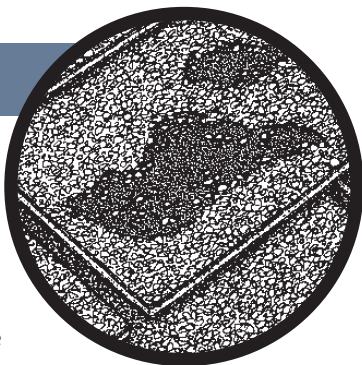
## GRANULE LOSS

Since extra granules are used in the manufacturing process, some granule loss is to be expected during the early years of your roof. Other factors, such as foot traffic, hail, snow or brushing tree limbs, may cause loose granules. However, exposed asphalt due to granule loss is a reason for concern and requires immediate attention.

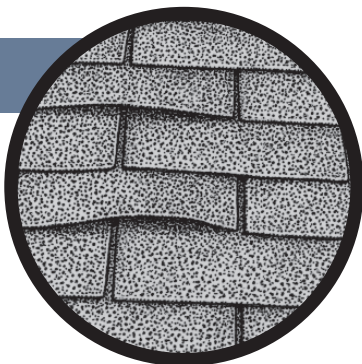
## BUCKLING

While not technically a sign of aging, a distortion of shingles known as buckling can occur months after original application. Lack of adequate attic ventilation can increase the moisture content of the decking material. This may cause expansion and movement of the wood deck to buckle shingles.
